# **Technical Report:** **March 2008 Groundwater** **Monitoring Program Results and** **Baseline Ecological Risk Assessment**

**Former JCI Stanley Tools Site**  
**Fowlerville, Michigan**

**April 2008**

# SEMI-ANNUAL GROUNDWATER SAMPLING RESULTS REPORT

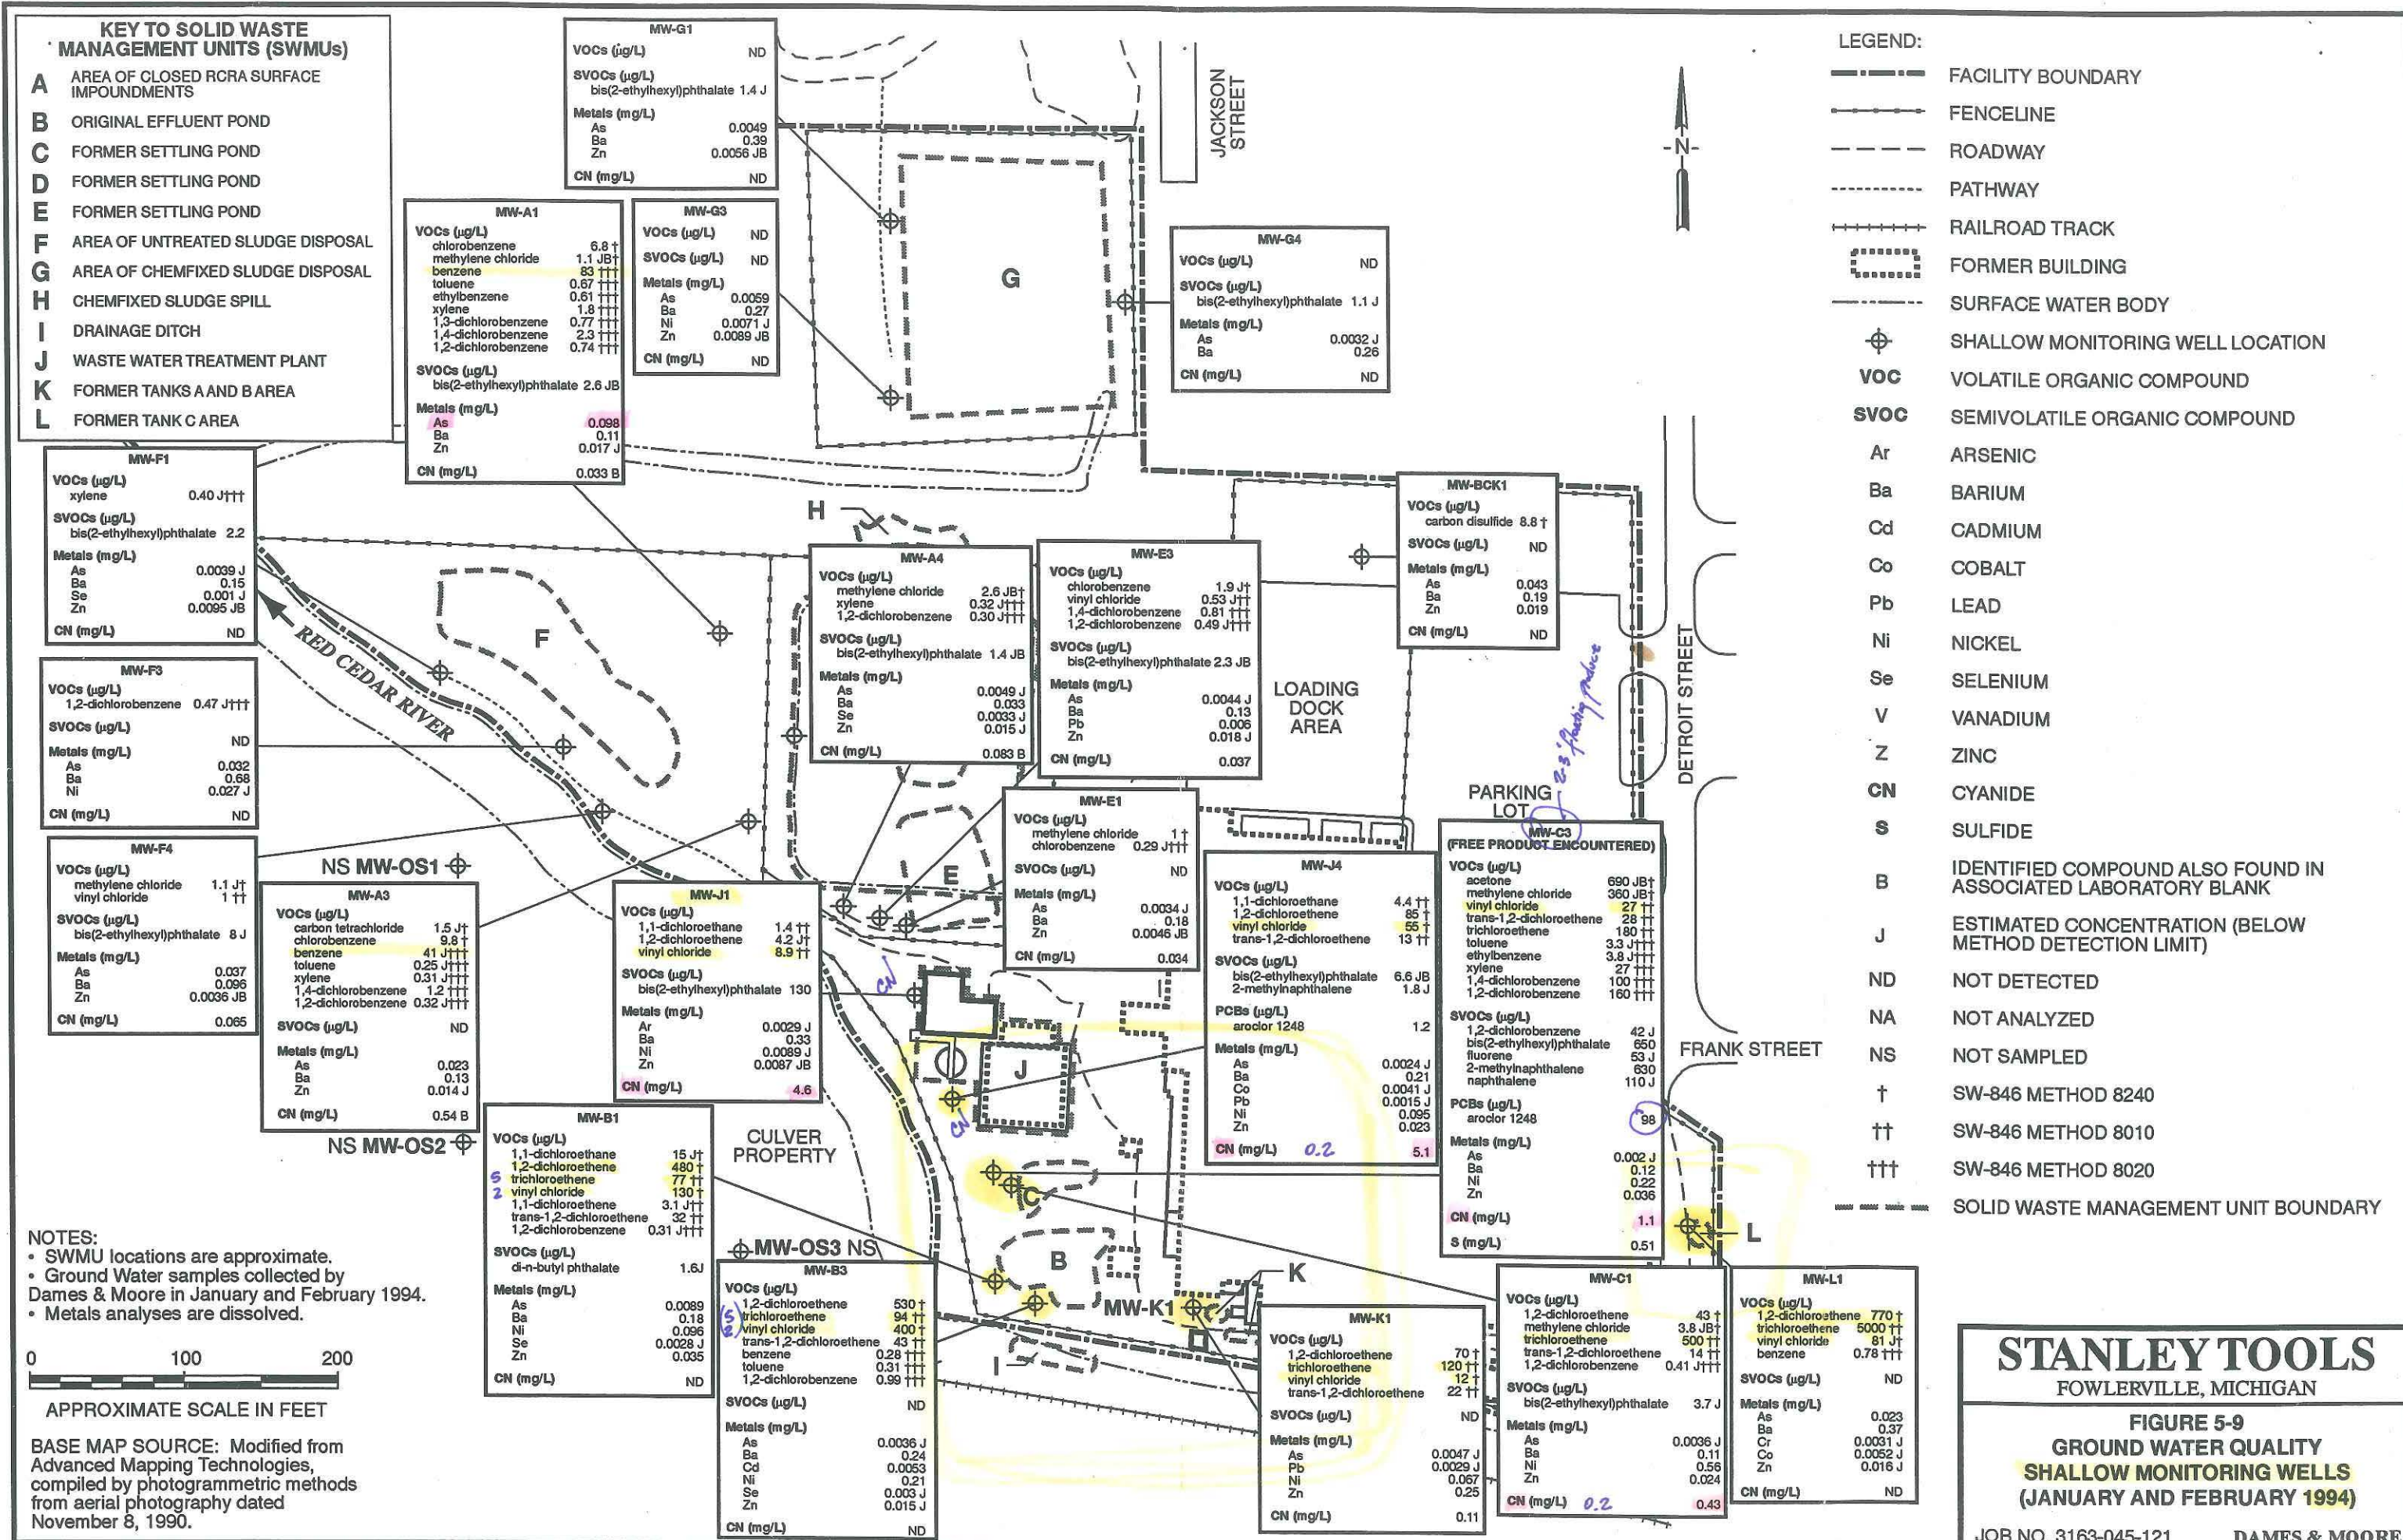
**FIGURE 5-10**  
**GROUND WATER QUALITY**  
**INTERMEDIATE AND DEEP**  
**MONITORING WELLS**  
**(FEBRUARY 1994)**

<b>VOCs (µg/L)</b>	
carbon tetrachloride	1.3 J†
chlorobenzene	2.0 J†
methylene chloride	1.1 JB†
1,3-dichlorobenzene	0.49 †††
1,4-dichlorobenzene	0.95 †††
<b>SVOCs (µg/L)</b>	
bis(2-ethylhexyl)phthalate	5.4 JB
<b>Metals (mg/L)</b>	
As	0.0096
Ba	0.16
Pb	0.0010 J
Se	0.0034 J
Zn	0.027
<b>CN (mg/L)</b>	0.0014 B

<b>VOCs (µg/L)</b>	ND
<b>SVOCs (µg/L)</b>	
bis(2-ethylhexyl)phthalate	1.4 J
<b>Metals (mg/L)</b>	
As	0.002 J
Ba	0.056
Ni	0.0075 J
Se	0.0014 J
Zn	0.0046 JB
<b>CN (mg/L)</b>	ND

<b>VOCs (µg/L)</b>	
methylene chloride	2.6 JB†
1,4-dichlorobenzene	0.81 †††
<b>SVOCs (µg/L)</b>	
bis(2-ethylhexyl)phthalate	8.1 JB
<b>Metals (mg/L)</b>	
As	0.014
Ba	0.18
Co	0.0035 J
Se	0.025
Zn	0.013 B
<b>CN (mg/L)</b>	0.013 B

<b>VOCs (µg/L)</b>	
carbon disulfide	13 †
<b>SVOCs (µg/L)</b>	ND
<b>Metals (mg/L)</b>	
As	0.006
Ba	0.13
Co	0.0053 J
Zn	0.0092 J
<b>CN (mg/L)</b>	ND

<b>VOCs (µg/L)</b>	ND
<b>SVOCs (µg/L)</b>	
bis(2-ethylhexyl)phthalate	5.4 J
<b>Metals (mg/L)</b>	
Ba	0.031
Se	0.001 J
Zn	0.0095 JB
<b>CN (mg/L)</b>	ND

<b>VOCs (µg/L)</b>	
tetrachloroethene	1.8 J†
<b>SVOCs (µg/L)</b>	ND
<b>Metals (mg/L)</b>	
As	0.0040 J
Ba	0.31 J
Zn	0.016 J
<b>CN (mg/L)</b>	0.017

<b>VOCs (µg/L)</b>	
vinyl chloride	17 †
<b>SVOCs (µg/L)</b>	ND
<b>Metals (mg/L)</b>	
As	0.0033 J
Ba	0.03
Zn	0.028
<b>CN (mg/L)</b>	16.9
<b>S (mg/L)</b>	0.95

<b>VOCs (µg/L)</b>	
acetone	33 †
1,2-dichloroethene	1.5 J†
1,1-dichloroethane	0.49 J††
Trichloroethene	0.47 ††
<b>SVOCs (µg/L)</b>	
bis(2-ethylhexyl)phthalate	3.2 J
phenol	3.9 J
<b>Metals (mg/L)</b>	
Sb	0.018 J
As	0.0036 J
Ba	0.1
V	0.0045 J
Zn	0.012 J
<b>CN (mg/L)</b>	ND
<b>S (mg/L)</b>	0.058

<b>VOCs (µg/L)</b>	ND
<b>SVOCs (µg/L)</b>	ND
<b>Metals (mg/L)</b>	
As	0.014
Ba	0.14
Se	0.0024 J
Zn	0.014 J
<b>CN (mg/L)</b>	ND

<b>VOCs (µg/L)</b>	ND
<b>SVOCs (µg/L)</b>	ND
<b>Metals (mg/L)</b>	
As	0.014
Ba	0.26
<b>CN (mg/L)</b>	0.066

<b>VOCs (µg/L)</b>	ND
<b>SVOCs (µg/L)</b>	
bis(2-ethylhexyl)phthalate	1.2 J
<b>Metals (mg/L)</b>	
As	0.013
Ba	0.17
Zn	0.13
<b>CN (mg/L)</b>	ND

<b>VOCs (µg/L)</b>	
benzene	0.54 †††
toluene	0.63 †††
chlorobenzene	0.67 †††
ethylbenzene	0.72 †††
xylene	2 †††
1,3-dichlorobenzene	0.51 †††
1,4-dichlorobenzene	0.51 †††
1,2-dichlorobenzene	0.46 J††
<b>SVOCs (µg/L)</b>	
bis(2-ethylhexyl)phthalate	10
<b>Metals (mg/L)</b>	
As	0.011
Ba	0.15
Zn	0.014 J
<b>CN (mg/L)</b>	ND

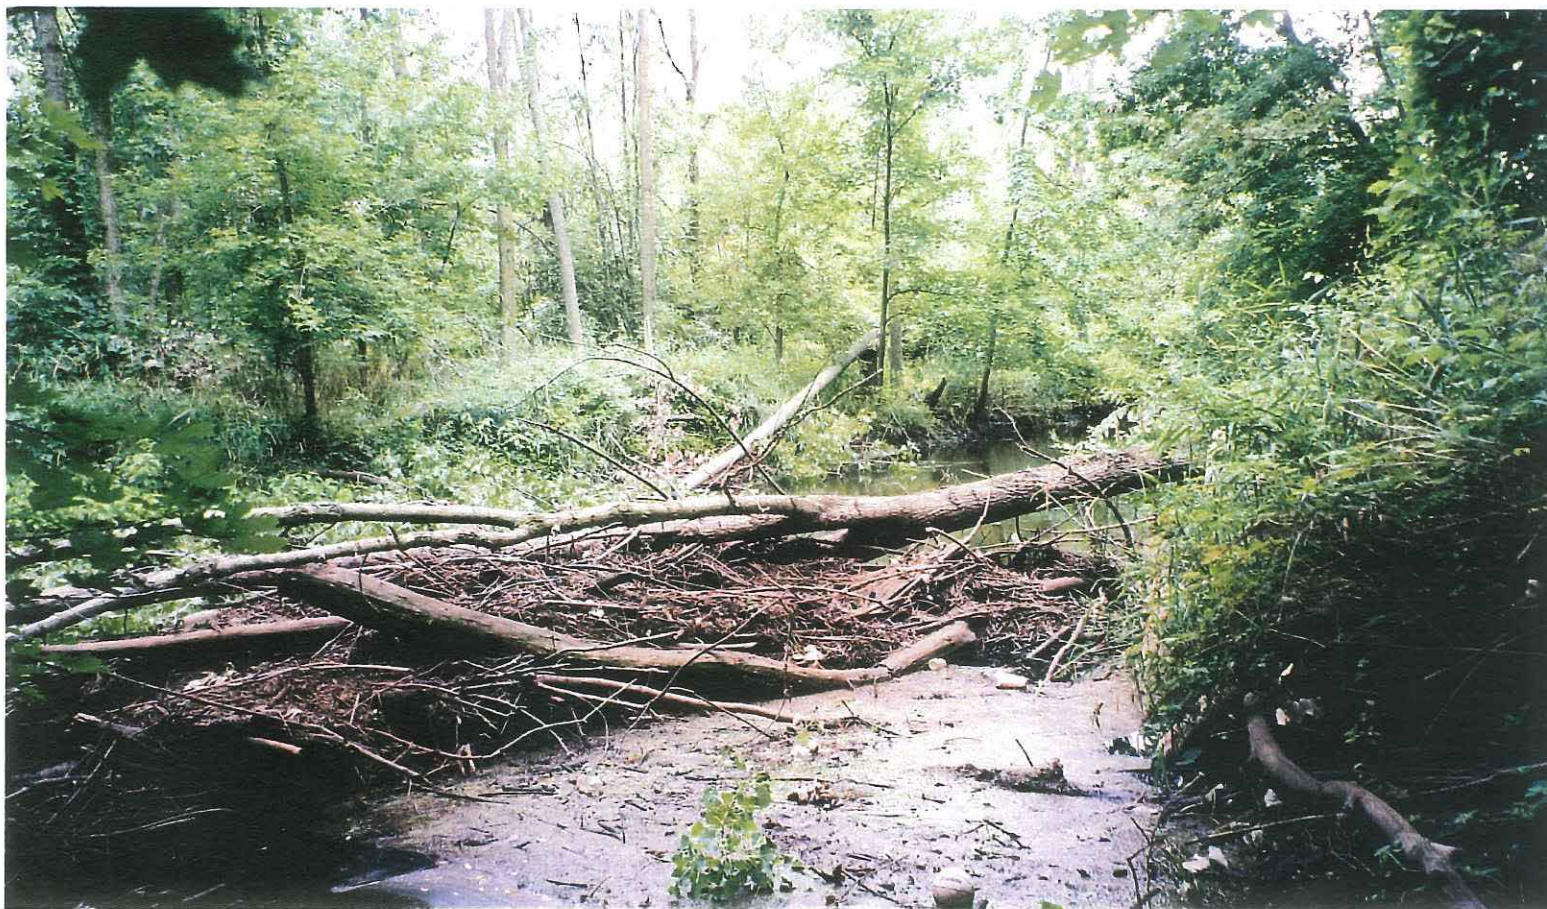
PHOTO 1

SUBJECT: Log jam on river immediately downstream of confluence with north ditch, between stations 01 and 02. Looking downstream (N).

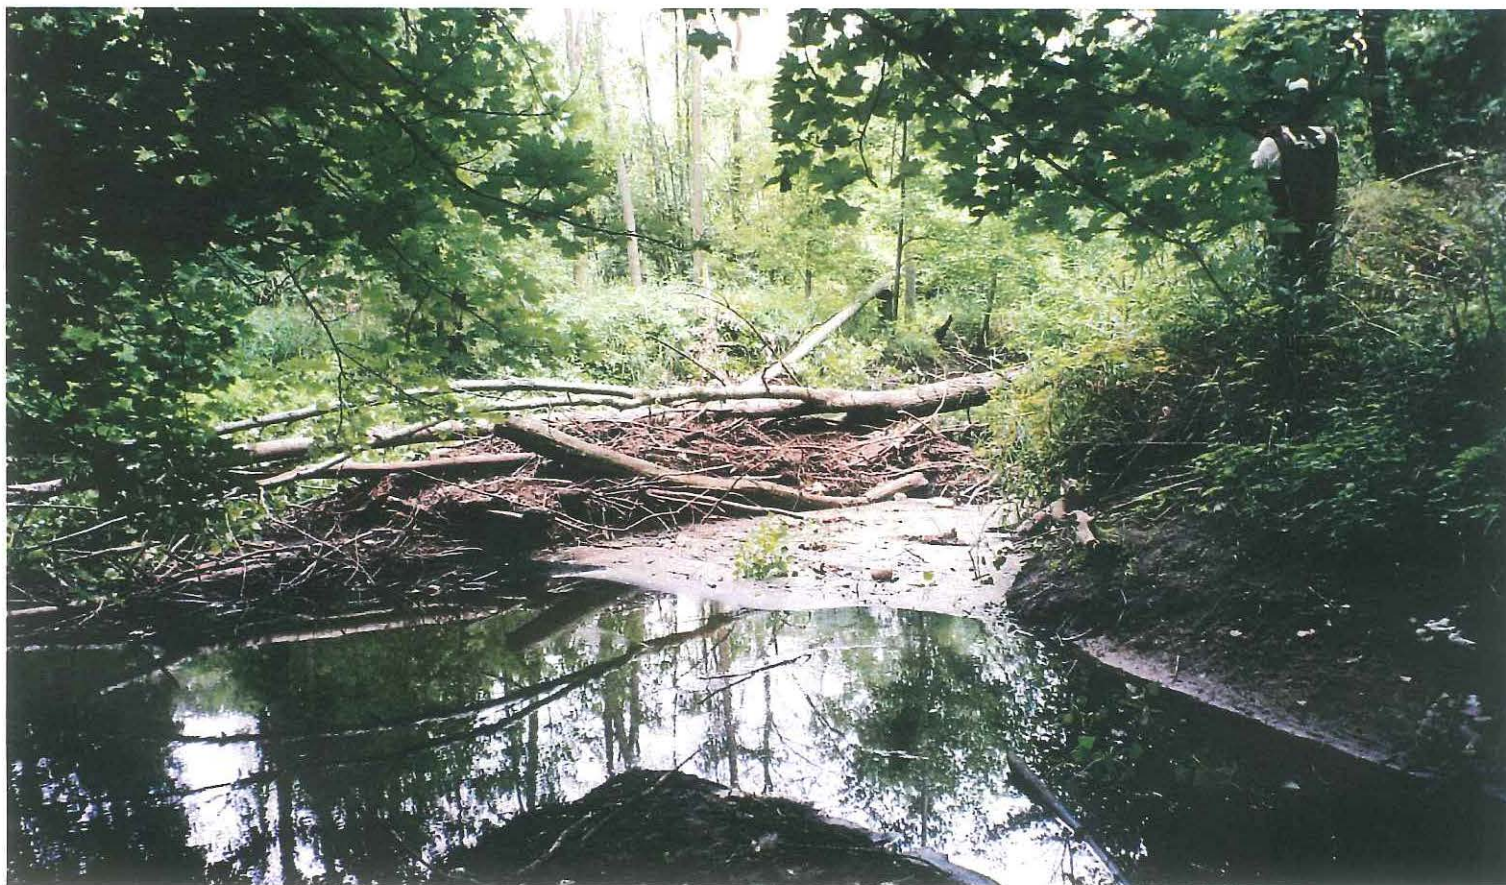
PHOTO 2

SUBJECT: Log jam on river immediately downstream of confluence with north ditch (right foreground, between stations 01 and 02)  
Looking NW.

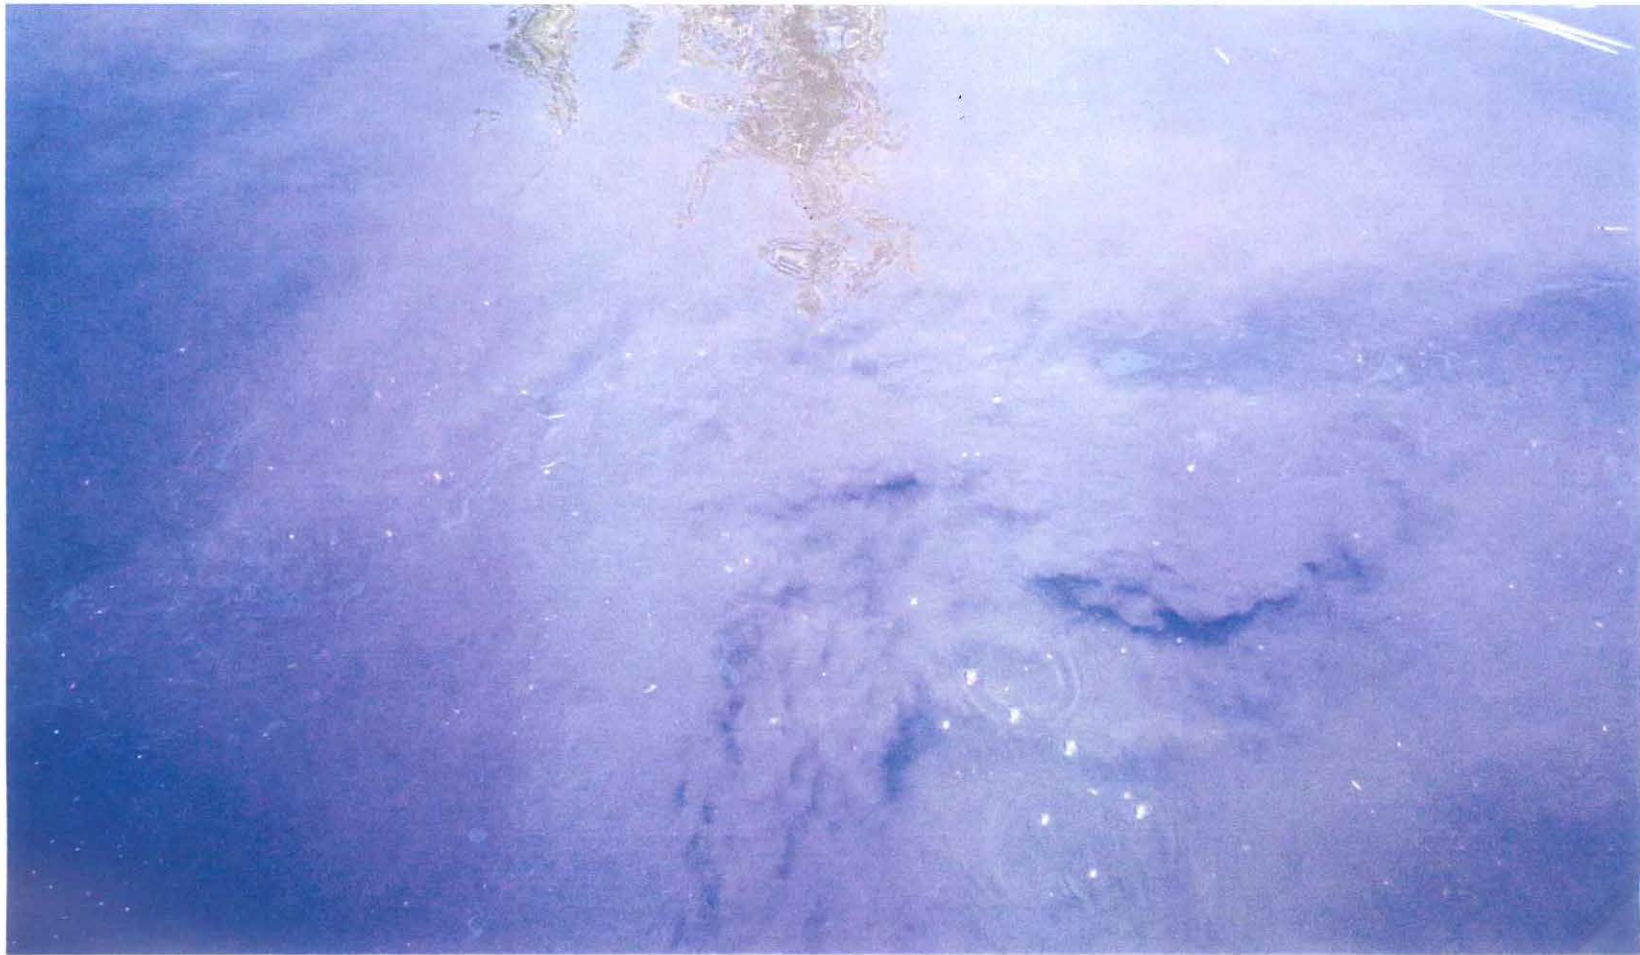
PHOTO 13

SUBJECT: Oily sheen on water after collecting sediment samples at SD-E2-003.

Oily sheen?  
pebbles?

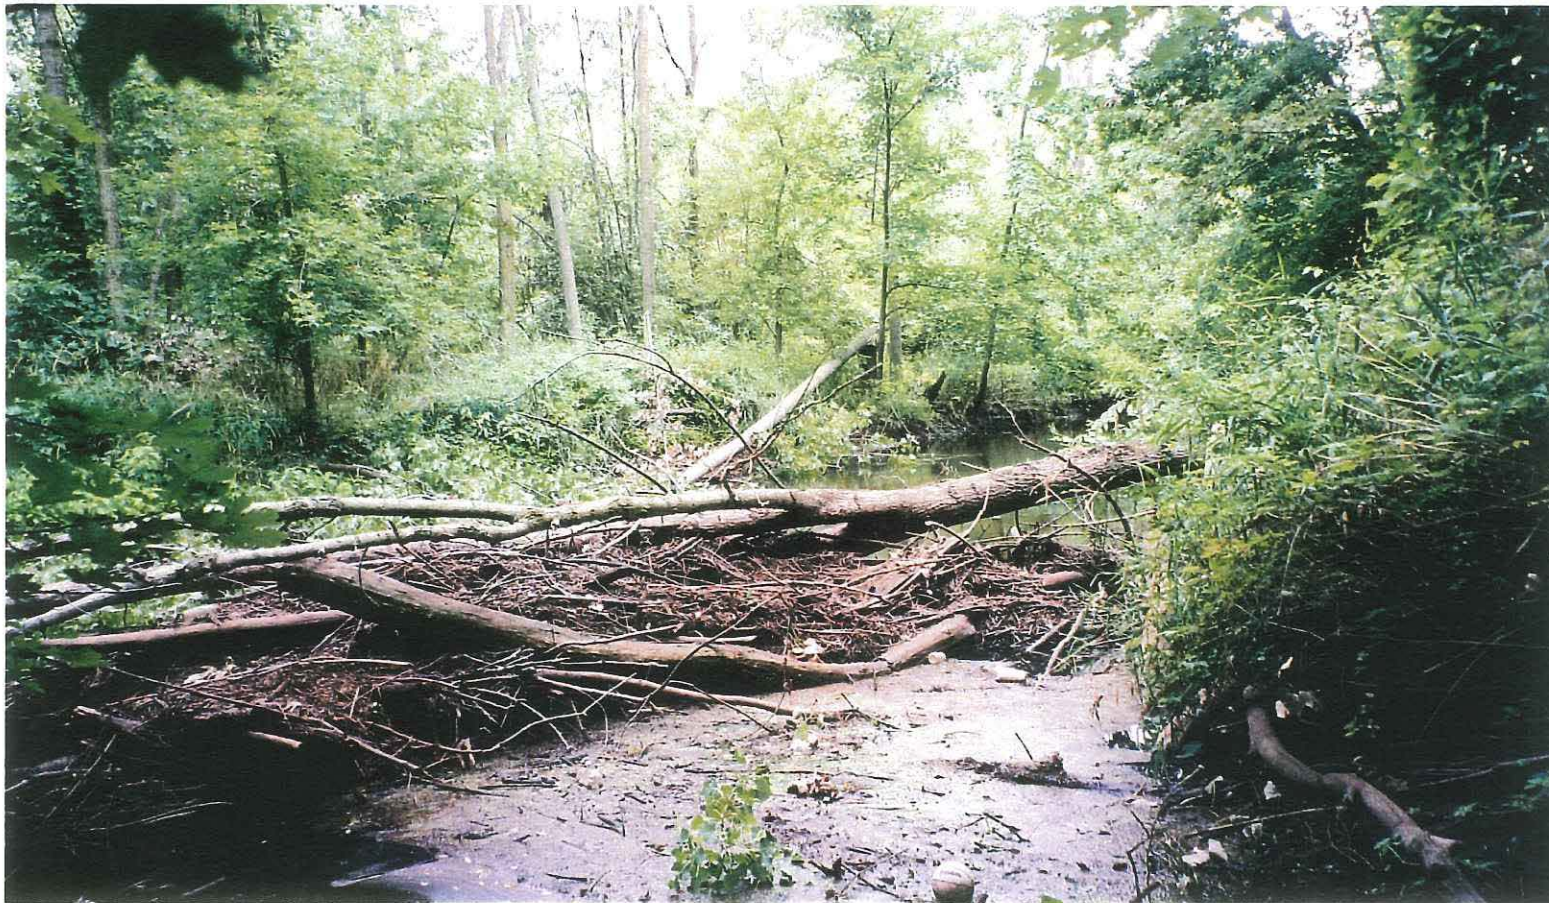
PHOTO 1

SUBJECT: Log jam on river immediately downstream of confluence with north ditch, between stations 01 and 02. Looking downstream (N).

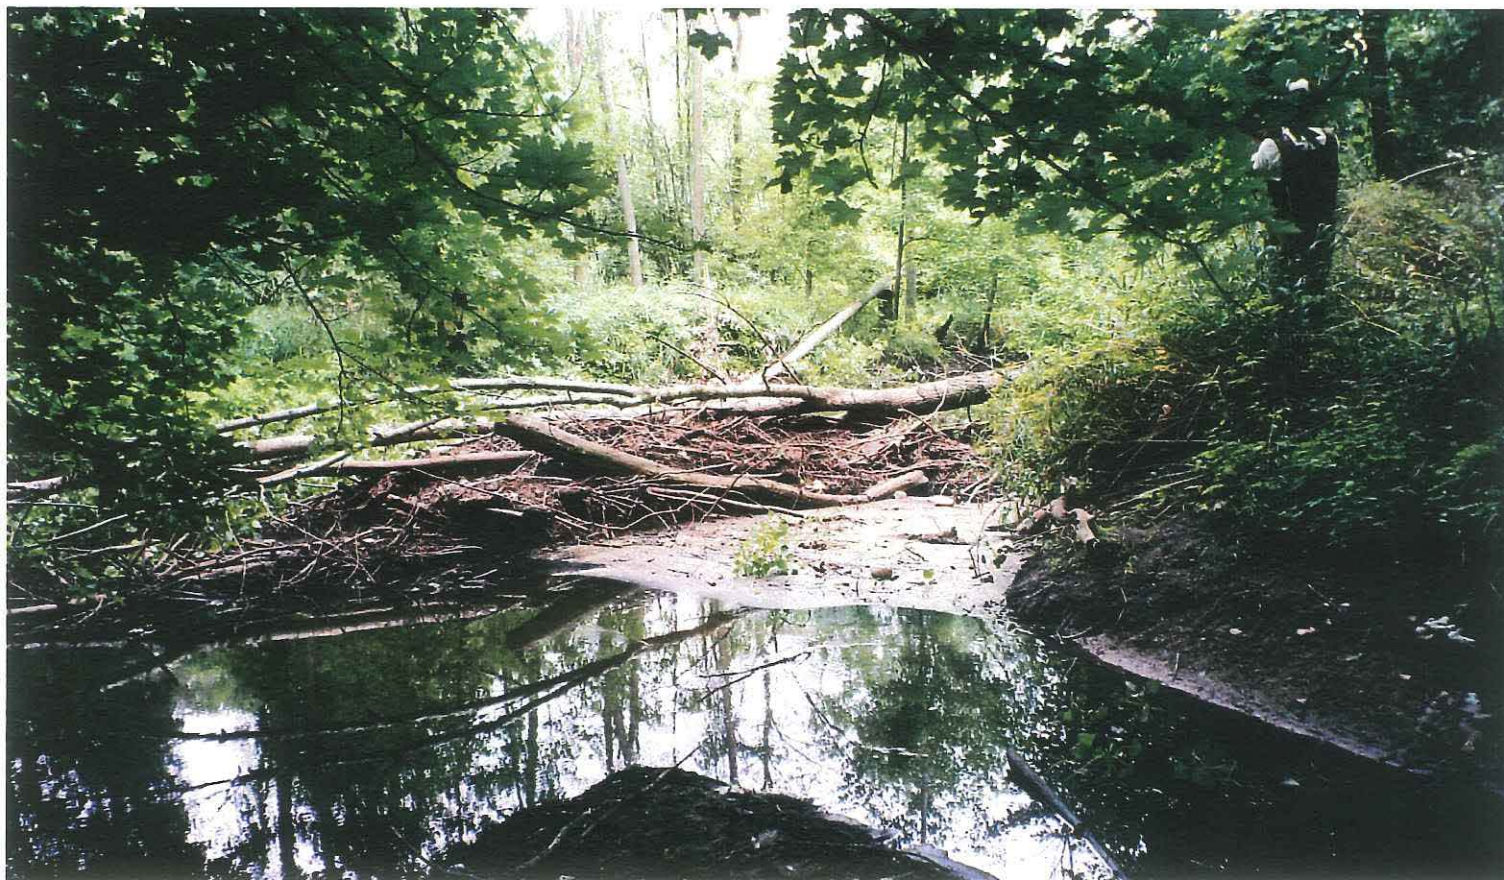
PHOTO 2

SUBJECT: Log jam on river immediately downstream of confluence with north ditch (right foreground, between stations 01 and 02)  
Looking NW.
